Test Report

Number	17-000810-PR13 (PB-K99-05-en)
Owner (Client)	ALUMINCO S.A. Megali Rahi 32011 Inofita Viotias Greece
Product	Safety Railings
Designation	Shipping name: Orbit Type 01
Details	Overall dimensions (W x H) 2710 mm x 1200 mm; Profiles Aluminium Profil; item-No: FSN-222, FSN-201, FSN-102, FSN-122 and FSN-906; Glass configuration HSG 6 mm / PVB film 1.52 mm / HSG 6 mm; Thickness 13.52 mm
Special features	Aluminium railing with glass panel
Order	Testing of Safety Rails
Contents	The test report contains a total of 10 pages and annexe (6 pages).
Note	The test report shall only be published in its unabbreviated form. The "Guidance Sheet for the Use of ift Test Documents" applies.

Railings test – Methodes and criteria

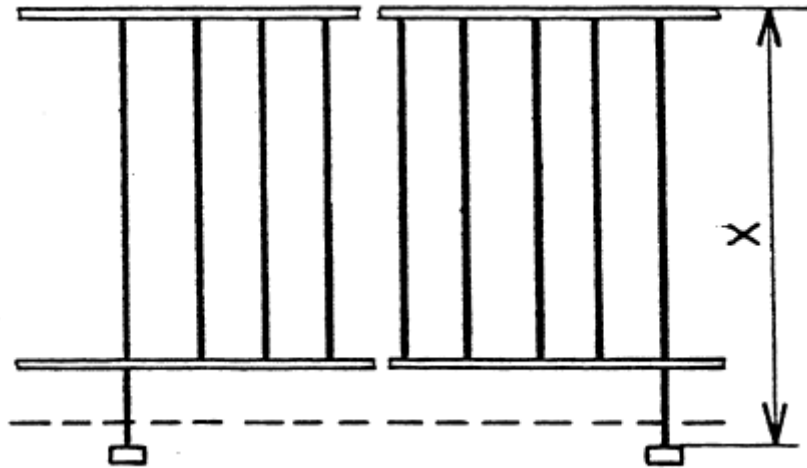
x being the distance lying between the top of the handrail and the anchorage point for the railings (see Fig. 2),

Fig. 2 Distance X

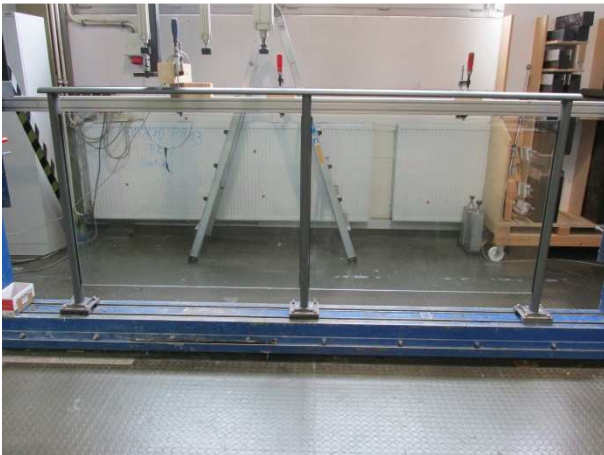
Picture 1 View of the test specimen

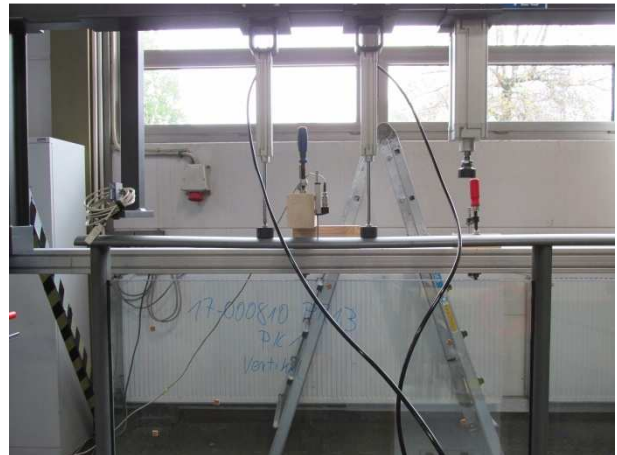
Picture 2 Static vertical test with load

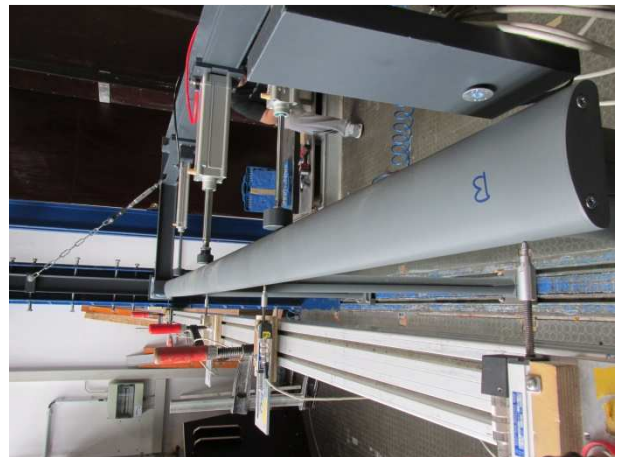
Picture 4 Deformation from the hand rail
